Inspection Report

PROPERTY INSPECTION REPORT

Concerning: xxx Sample Street, Forney, TX 73135

By: Ted Wulff TREC Professional Inspector License #22688 / Buy Smart Home Inspections 10/
27/2017

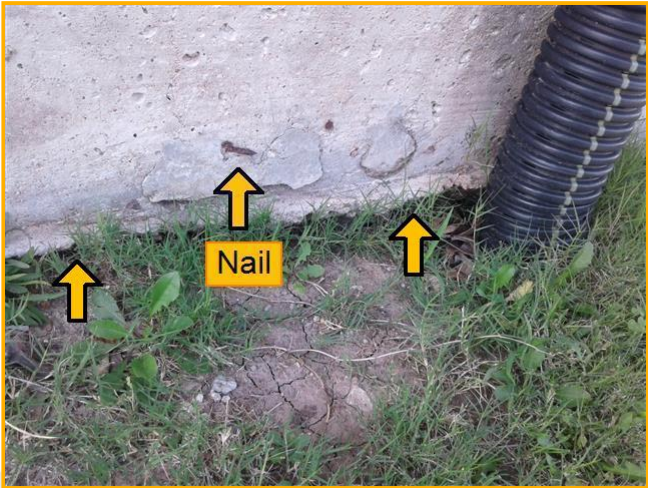
A. Item 3(Picture)

(3) The foundation was undermined by erosion cause by water. The owner indicated that the underground drainage pipes attached to the downspouts were installed after this problem was detected as a solution. This appears to be an adequate solution, so no further repairs are recommended other than removal of the rusty nail, which may cause injury.

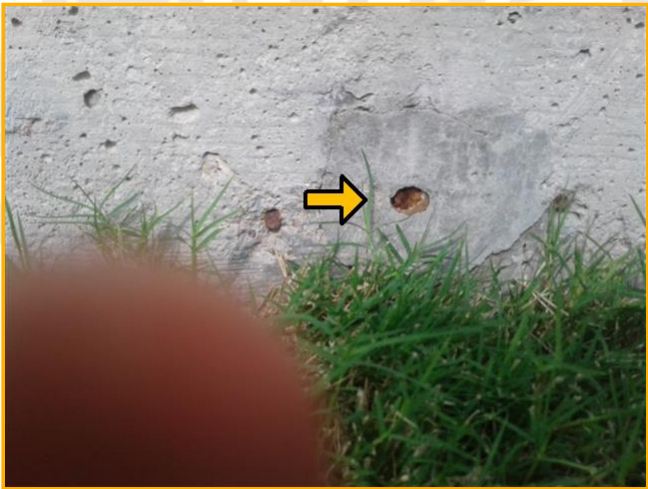
A. Item 4(Picture)

(4) Exposed/rusted post tension cable ends existed at the rear perimeter beam indicating the need for remedial action. Exposure to the elements can cause rusting and reduced strength. Per the Post-Tensioning Institute (PTI), the tendon tails should be cut back from the face of the foundation approximately 1” and the tendon pocket then filled with a non-shrink grout. An alternative method allows the grout covering the tendon to be reduced to 1/8” provided an approved tendon protection cap is installed. PTI requirements should be complied with. Please note that some areas of the perimeter beam(s) was/were hidden from view by soil, vegetation, or flatwork, therefore, other exposed/ rusted cable tendons may exist.

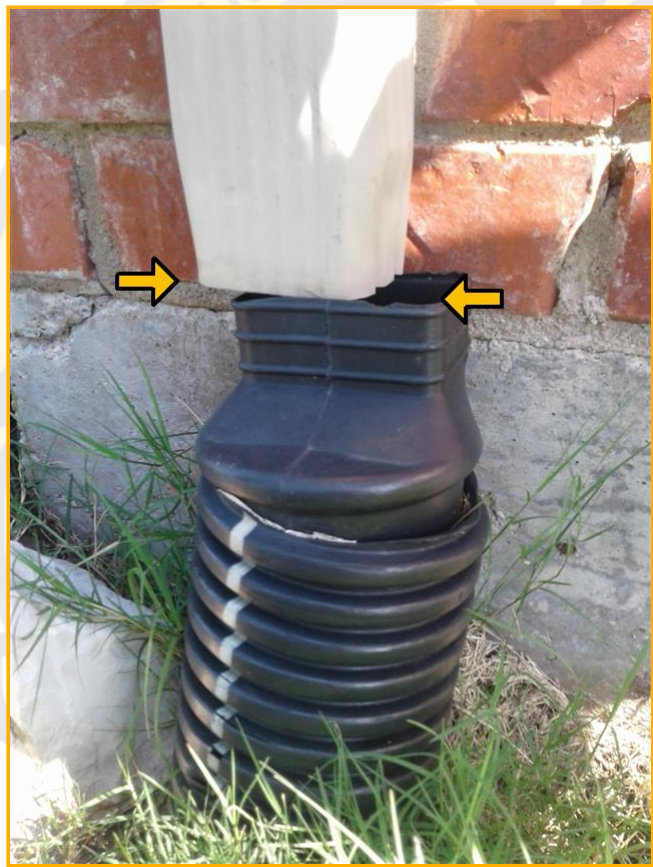
B. Item 1(Picture)

(2) The downspout on the front of the house was disconnected from the underground drain line, which can cause problems with washing out the soil near the foundation. Recommend that it be re-connected as designed by a qualified contractor.

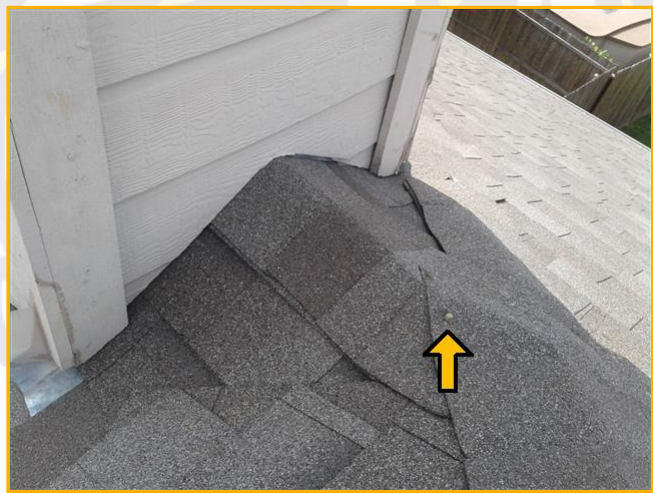
C. Item 1(Picture)

(2) The ridges of the roof had some exposed nailheads, which can lead to eventual leakage through the penetration. Recommend that these be caulked by a qualified contractor to solve the problem.

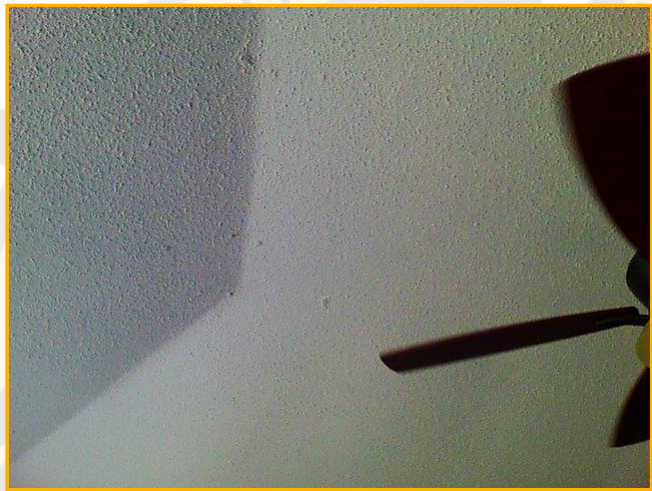
F. Item 1(Picture) Living Room

(2) The anomaly depicted in the thermal image below (red/yellow area) indicates warm/hot temperatures which may be due to insufficient insulation, missing insulation, or insulation voids. An appropriate contractor should be retained for further evaluation and needed action. NOTE: This evaluation should not be considered as an energy audit. An appropriate contractor should be retained if an energy audit is desired.

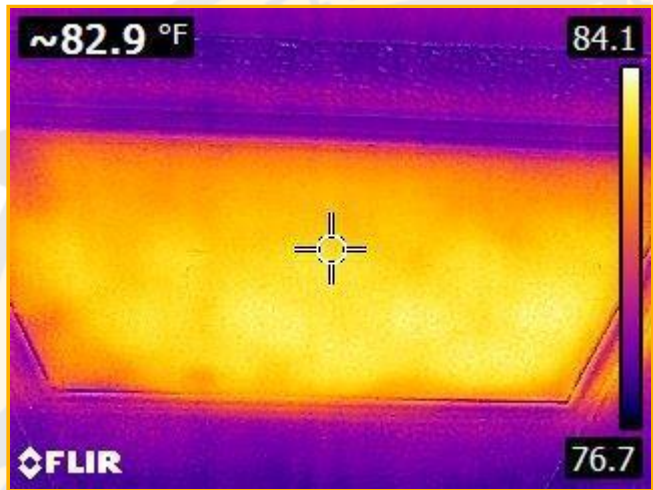
F. Item 3(Picture)

(4) The interior attic scuttle access was not adequately weatherstripped and insulated as shown in yellow in the attached thermal image, which can lead to energy inefficiency of the HVAC (heating, ventilation and air conditioning) system. Recommend that it be repaired by a qualified contractor.

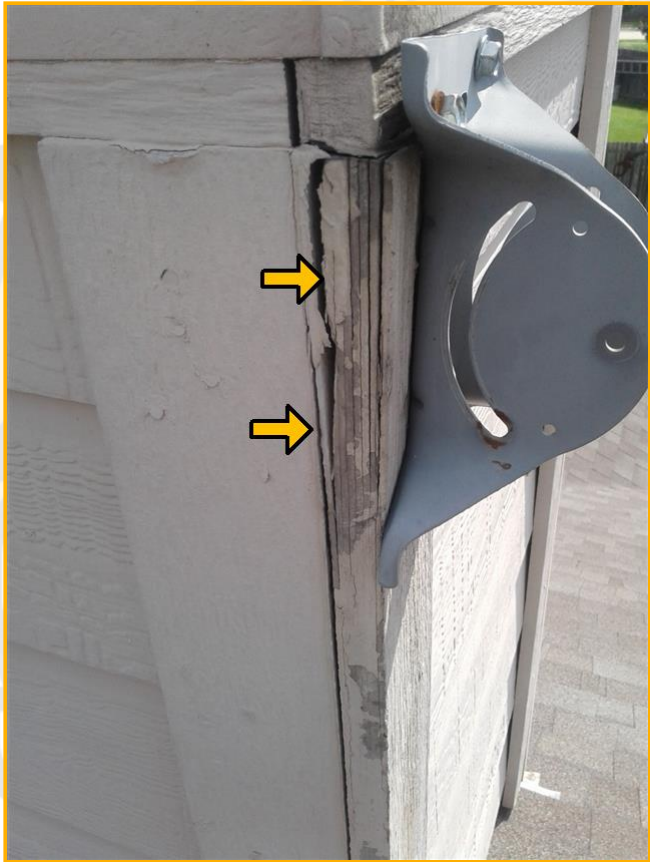
J. Item 1(Picture)

(2) Some deterioration was noted on the wood on the chimney and leads to further damage through moisture intrusion Recommend repair/re-paint by a qualified contractor.

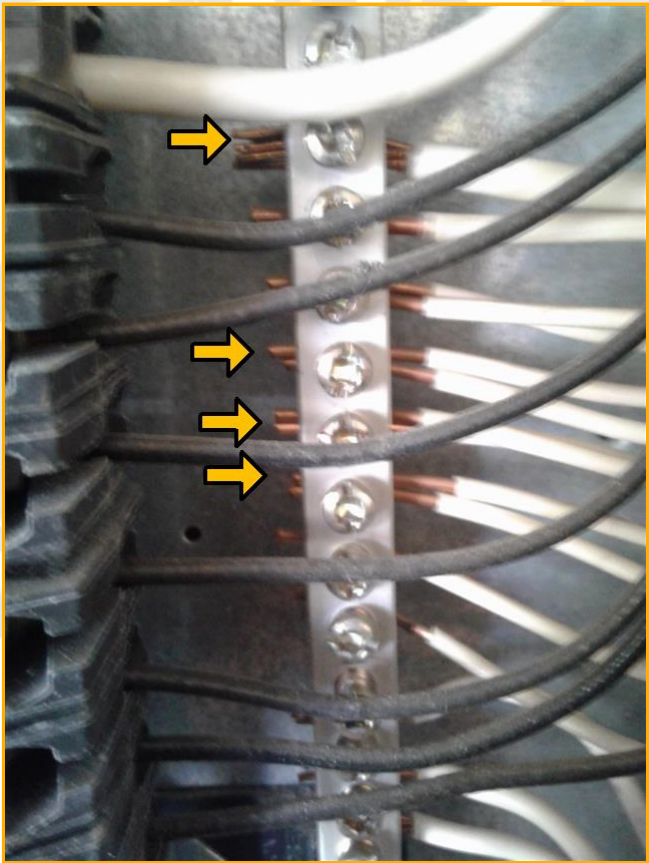
A. Item 1(Picture)

Some of the neutral conductors had multiple taps into single holes in the neutral bus bar. This can lead to loose electrical connections with those circuits. Recommend that neutral connections be separated to having only one neutral conductor per lug by a licensed electrician.

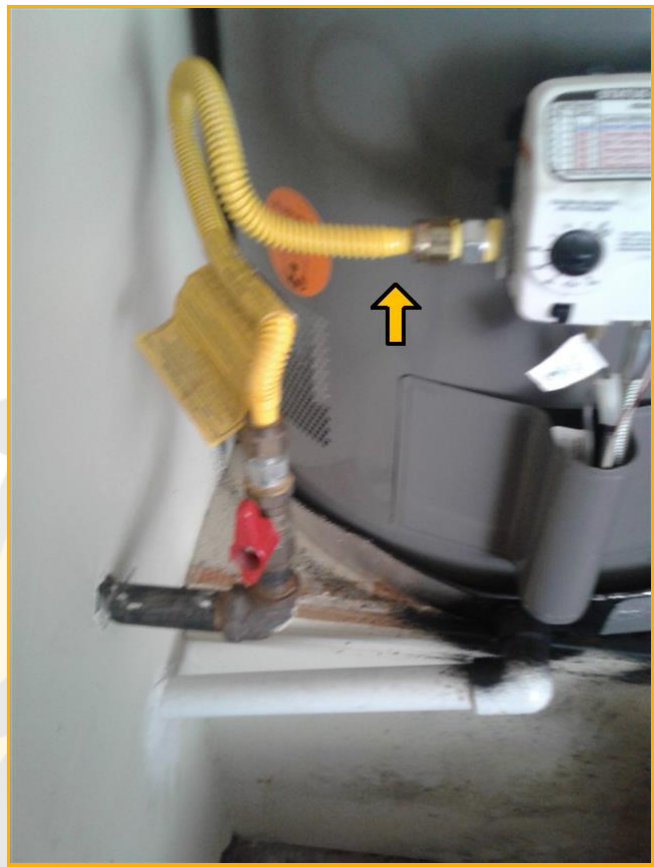
A. Item 4(Picture)

could more easily allow contaminants to get in the burner reducing efficiency. Recommend that sediment traps be installed on all gas appliance connections by a qualified contractor.

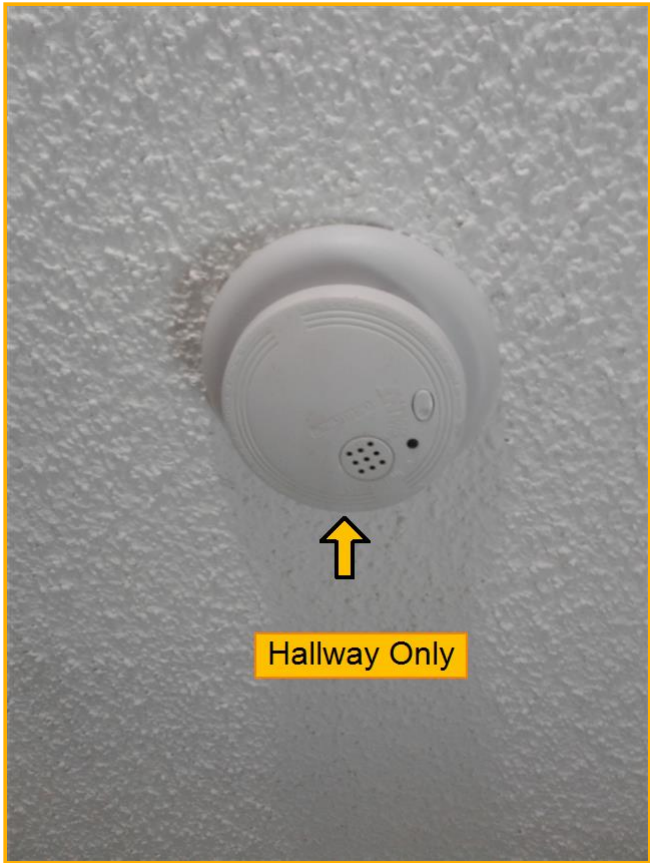
B. Item 9(Picture) Hallway

(7) Smoke alarms are required to be placed in all bedrooms and outside them in the adjacent room/hallway. Additionally a carbon monoxide (CO) alarm is required to be outside of each bedroom area. The smoke alarms were missing from the bedrooms and no CO alarm was installed. All smoke alarms should be AC powered and interconnected. These are safety issues for protection against fires or carbon monoxide poisoning.

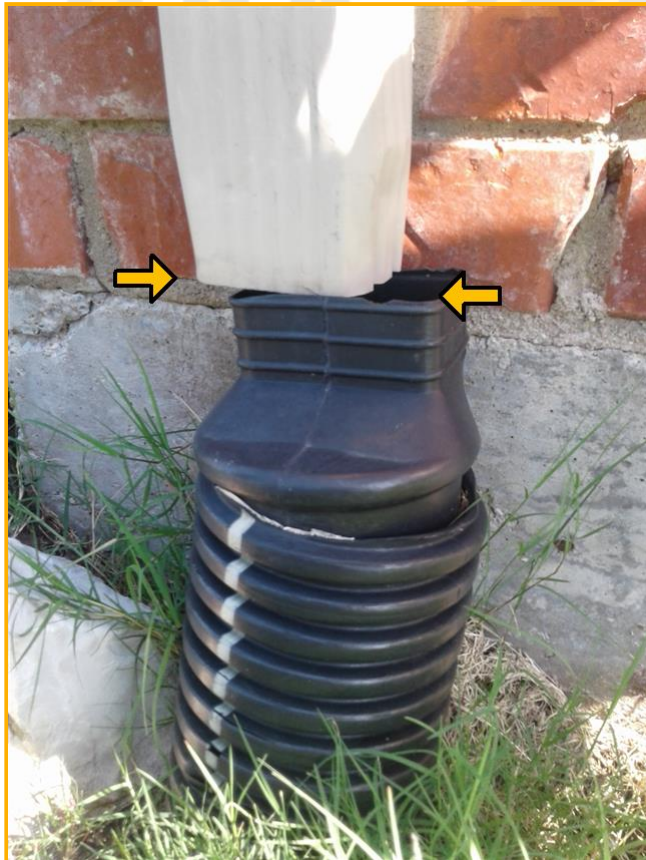
B. Item 1(Picture)

(2) The downspout on the front of the house was disconnected from the underground drain line, which can cause problems with washing out the soil near the foundation. Recommend that it be re-connected as designed by a qualified contractor.

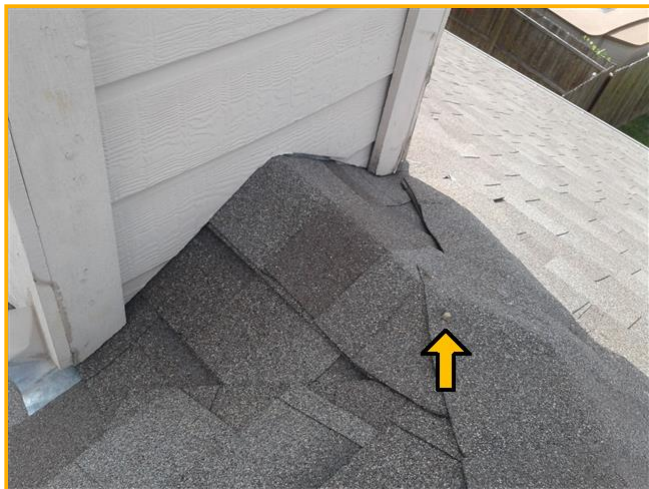
C. Item 1(Picture)

(2) The ridges of the roof had some exposed nailheads, which can lead to eventual leakage through the penetration. Recommend that these be caulked by a qualified contractor to solve the problem.

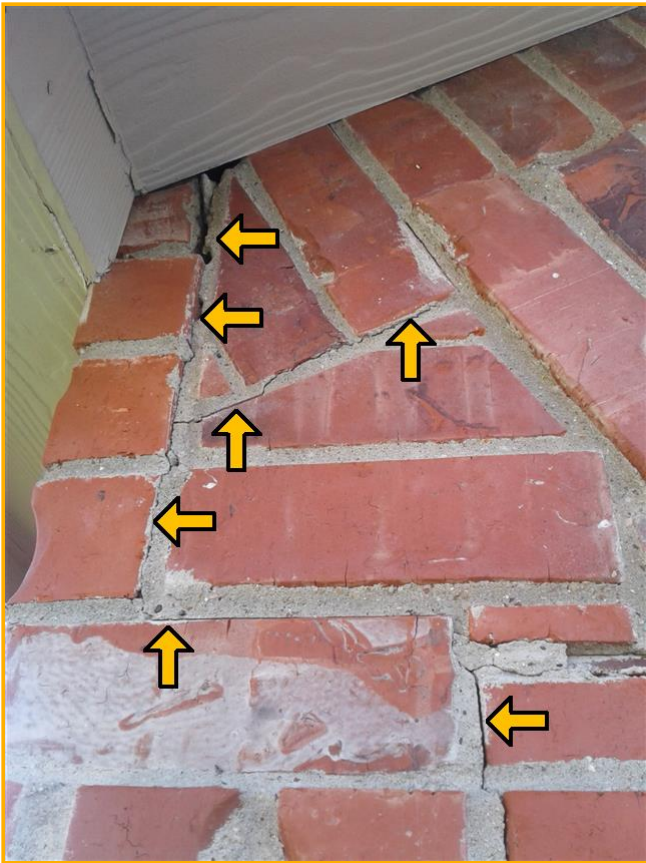
E. Item 1(Picture) Right Front

(1) The mortar joints in these areas are subject to further deterioration and moisture intrusion. Recommend that they be re-pointed by a qualified mason to prevent this future deterioration.

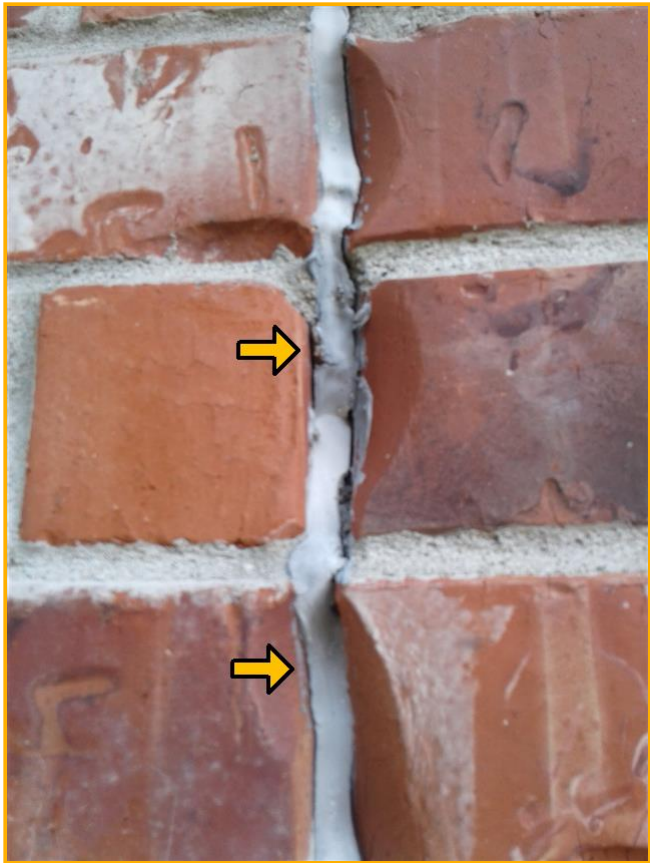
E. Item 4(Picture)

(2) This penetration in the exterior wall gives opportunity for moisture and insects to enter the structure. Recommend that the space be sealed by a qualified contractor to prevent moisture and/or insect damage.

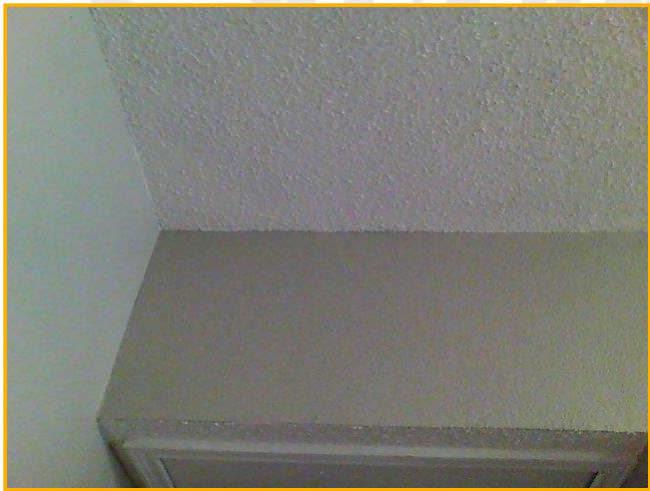
E. Item 5(Picture) Hallway entrance

(3) The anomalies depicted in the thermal image below (red/yellow area) indicates warm/hot temperatures which may be due to insufficient insulation, missing insulation, or insulation voids. An appropriate contractor should be retained for further evaluation and needed action. NOTE: This evaluation should not be considered as an energy audit. An appropriate contractor should be retained if an energy audit is desired.

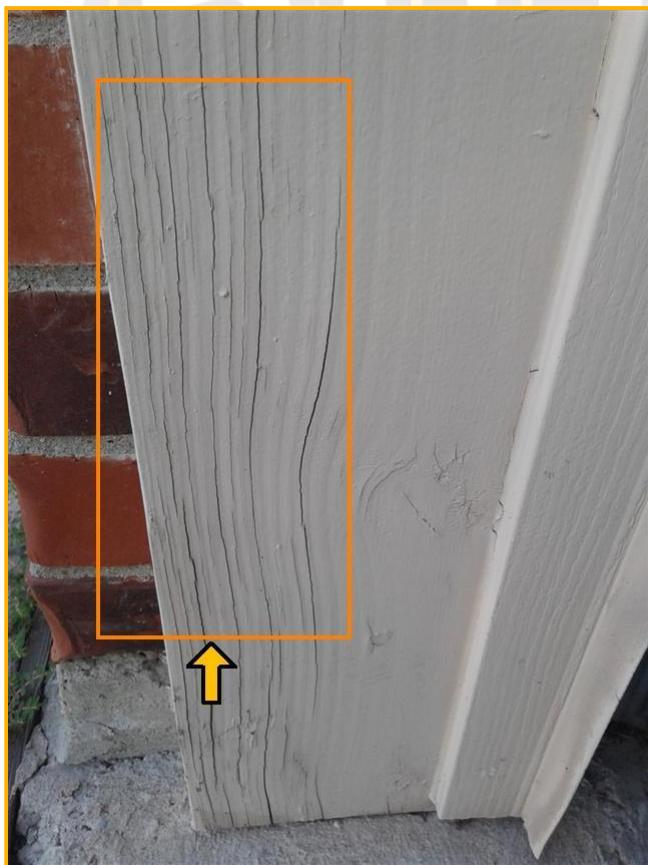
G. Item 1(Picture)

(2) The garage door frames showed signs of weathering, which can lead to moisture damage, although no rot was yet detected. Recommend that it be scraped and re-painted to maintain the integrity of the wood.

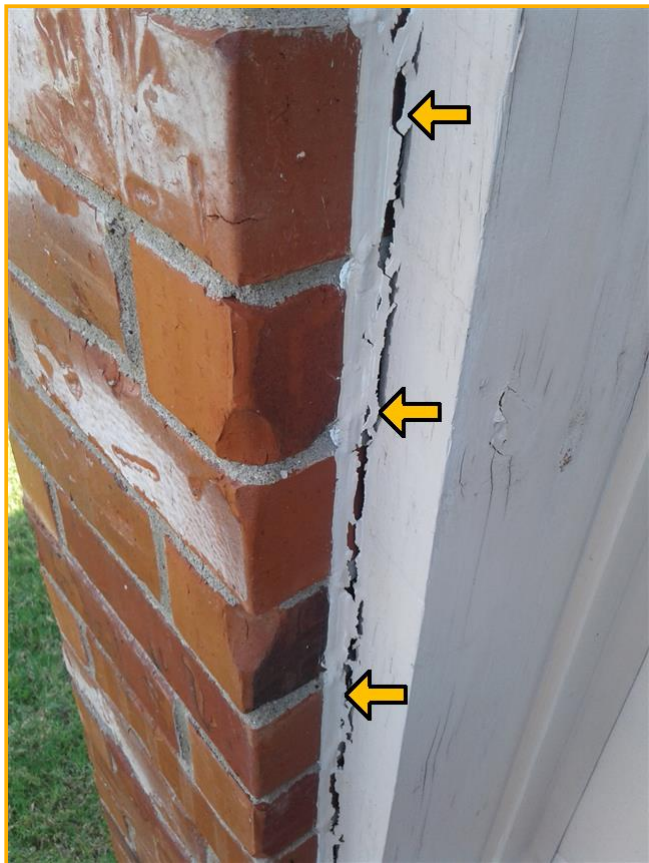
G. Item 2(Picture)

(3) The garage door frames had some damaged caulking on the edge, which could lead to moisture intrusion and water damage. Recommend that the caulked joints be scraped and re-caulked to help maintain the integrity of the wood.

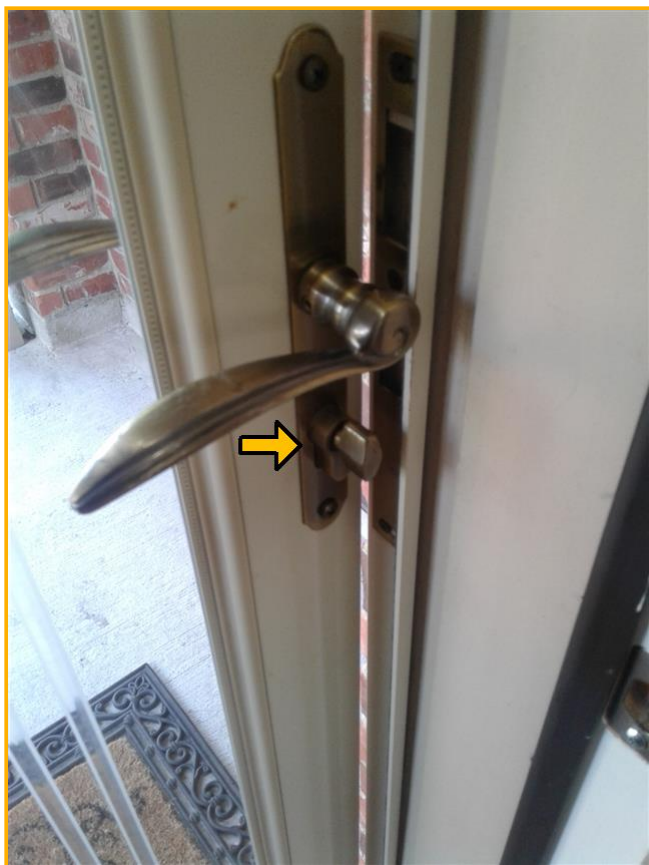
G. Item 3(Picture)

(4) The lock on the front storm door would not latch making the storm door un-lockable. Recommend that a door contractor be engaged to repair this condition.

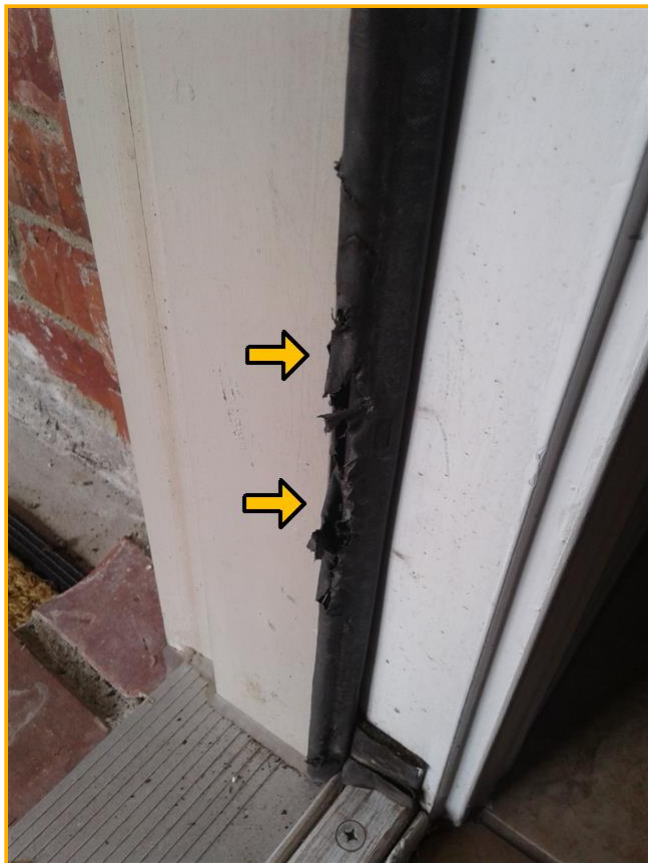
G. Item 4(Picture)

(5) The weatherstripping on one or more doors was damaged and is no longer doing a good job of sealing off air leaks, which can lead to wasted energy for heating and cooling. Recommend that they be replaced by a qualified contractor to restore the weather seal protection.

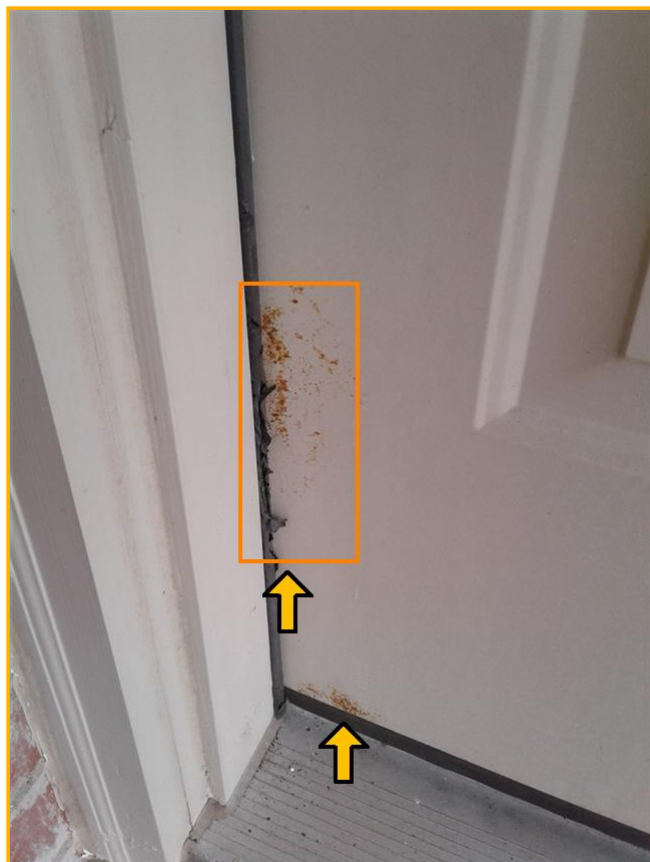
G. Item 5(Picture)

(6) The rear exterior metal door is showing signs of corrosion from moisture intrusion, which can lead to further door deterioration. Recommend that the rust be cleaned off and the door re-painted to prevent further moisture damage by a qualified contractor.

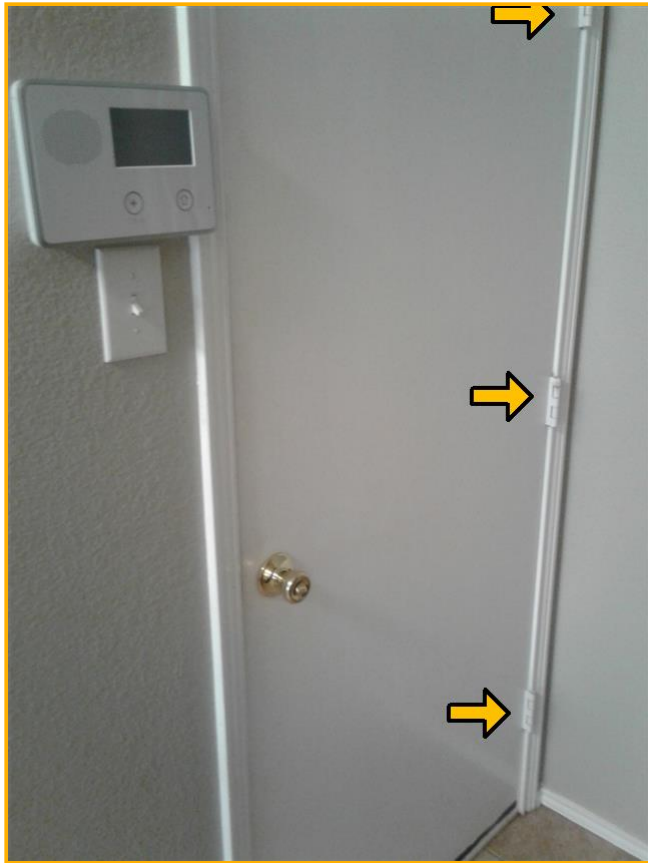
G. Item 6(Picture)

(7) The door leading to the garage did not have a self closing mechanism or self closing hinges to keep out carbon monoxide and to ensure it is an effective fire barrier. Recommend that it be made self closing by a qualified contractor.

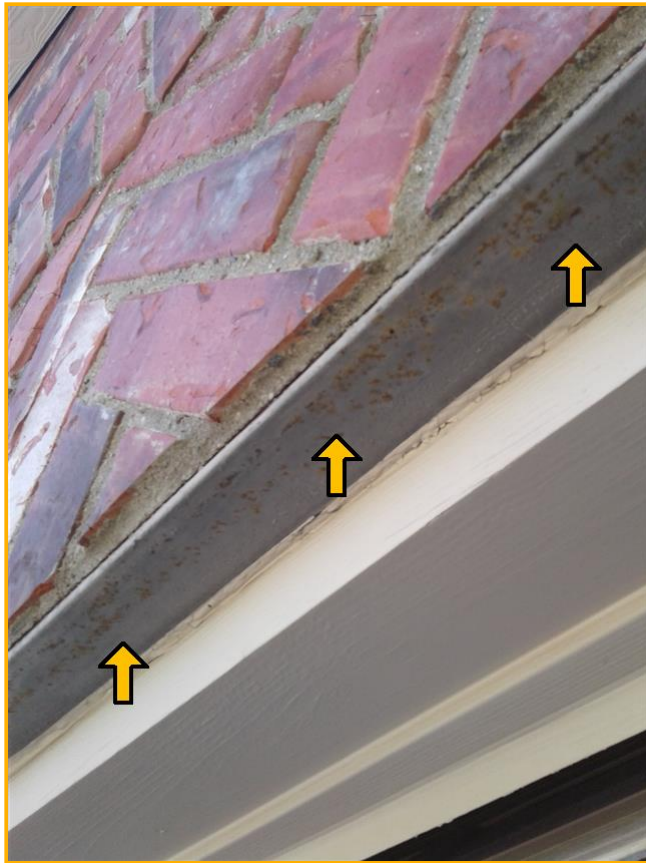
G. Item 7(Picture)

(8) The lintels above the garage doors were showing signs of corrosion, which can crack the surrounding brick as the metal expands with iron oxide. Recommend that they be cleaned and painted to avoid this from happening by a qualified contractor.

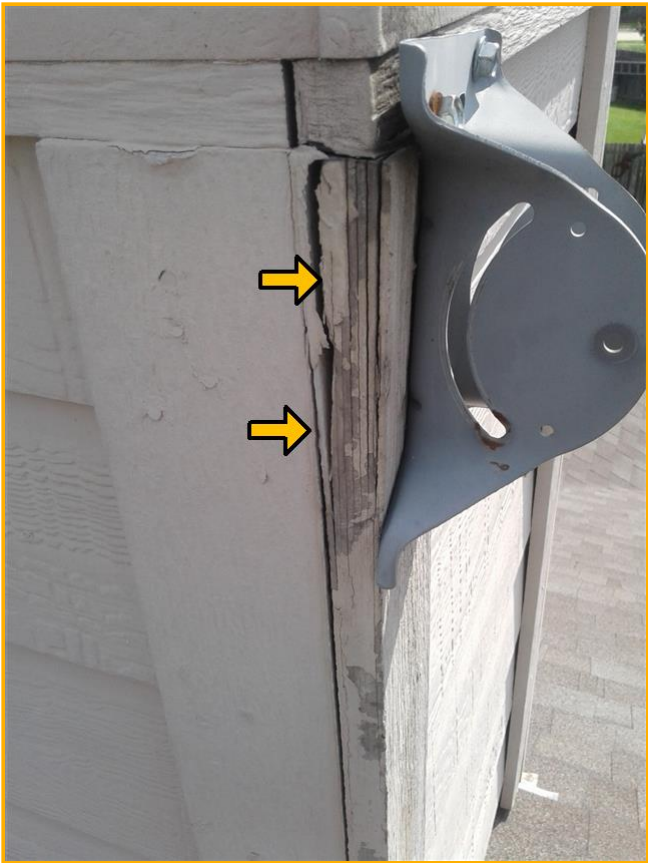
J. Item 1(Picture)

(2) Some deterioration was noted on the wood on the chimney and leads to further damage through moisture intrusion
Recommend repair/re-paint by a qualified contractor.

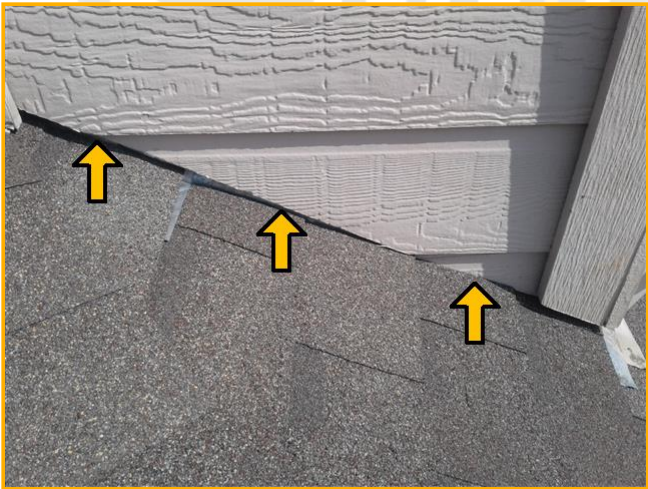
J. Item 2(Picture)

(3) The sides of the chimney siding are too close to the roofing surface, which can lead to moisture absorption and deterioration of the siding, although no damage was noted from this condition at the time of the inspection. Recommend that it be cut 1-2" above the roofing surface to prevent further damage from occurring by a qualified contractor.

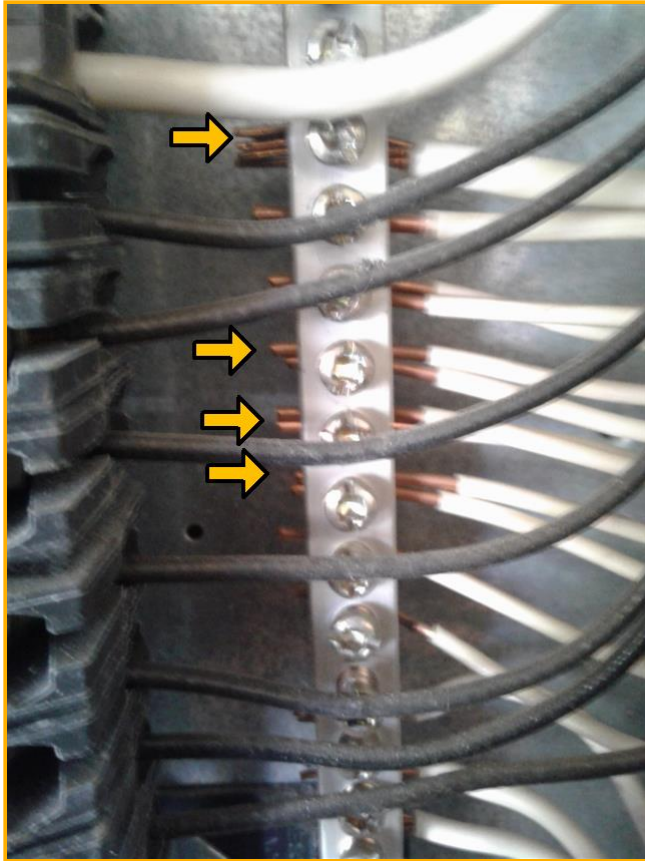
A. Item 1(Picture)

Some of the neutral conductors had multiple taps into single holes in the neutral bus bar. This can lead to loose electrical connections with those circuits. Recommend that neutral connections be separated to having only one neutral conductor per lug by a licensed electrician.

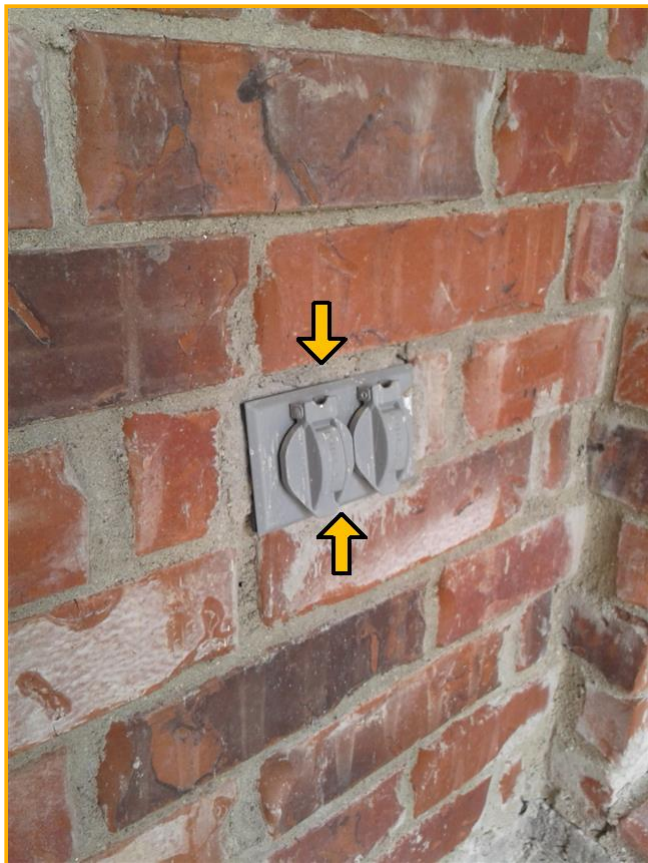
B. Item 2(Picture)

(3) This outlet and cover were loose, creating a condition where the wire connections could work themselves loose over time. The loose wires would then create an electric arc and therefore a fire hazard if not corrected. It is recommended that a licensed electrician confirm that the wires and outlet are adequately tightened to prevent this fire hazard condition.

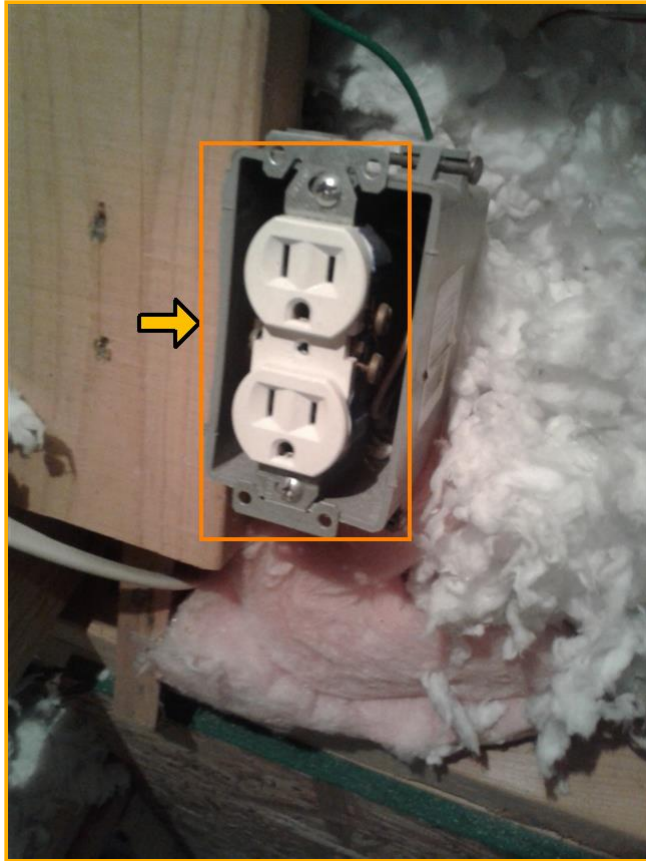
B. Item 6(Picture)

(5) There was a missing electric outlet/switch cover plate in the attic, which poses an electrocution hazard from inadvertent contact with energized components. Recommend that these devices be covered with a new cover plate to prevent accidental injury to occupants.

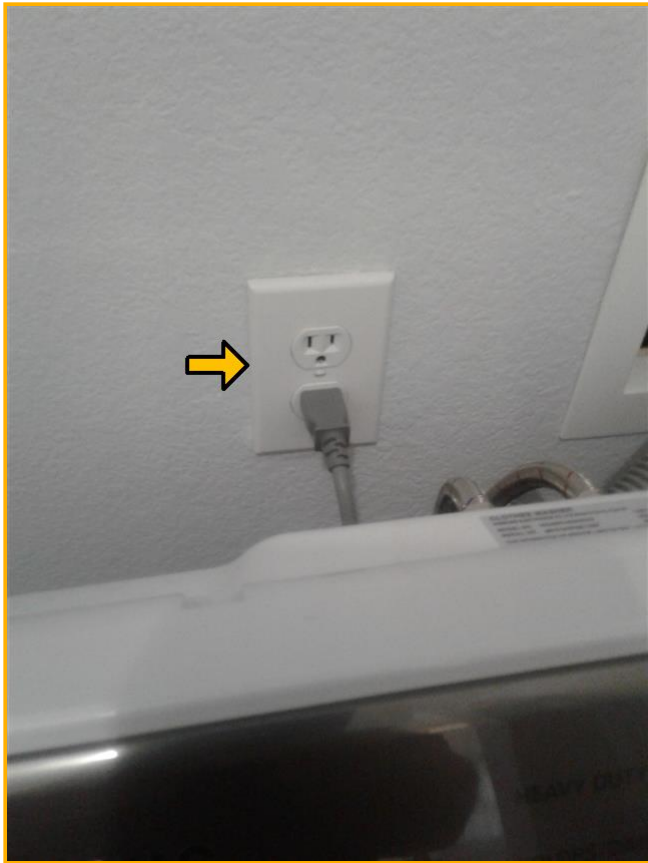
B. Item 7(Picture)

(6) Some of the outlets were not GFCI (Ground Fault Circuit Interrupter) rated (outdoor, utility room and garage) , which was likely not required when the house was built. It is a current standard however and represents an enhanced safety measure if installed. The State of Texas requires that missing GFCI outlets be called out as deficient in recognition of the advantages of having these available. GFCI outlets should be installed in kitchens, laundry rooms, wet bars, garages, bathrooms and all exterior area. Recommend that a licensed electrician be retained to accomplish the conversion. Learn more about GFCI outlets at: <https://www.safeelectricity.org/information-center/library-of-articles/55-home-safety/317-ground-fault-circuit-interrupters-gfcis>

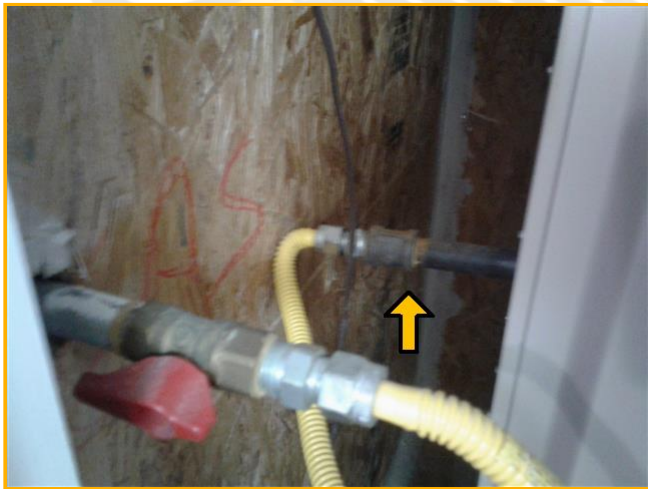
A. Item 2(Picture)

(2) The furnace gas supply line was missing a sediment trap, which are designed to help keep with burner assemblies clean and burn efficiently. Recommend that a sediment trap be installed by a licensed plumber as required.

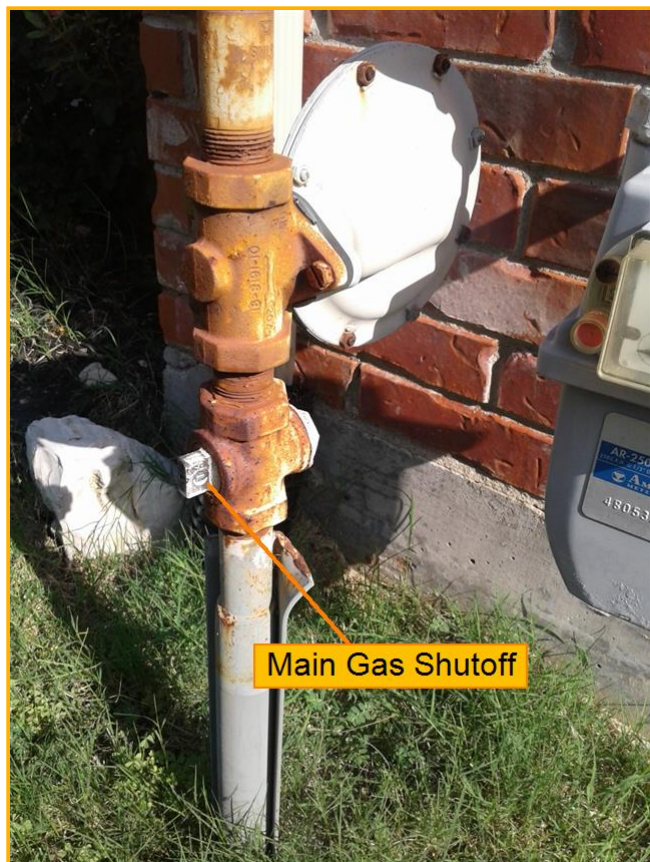
A. Item 2(Picture)

(3) The gas supply pipe entering the house was found to be corroded, which can cause gas leaks in the future if not taken care of. Recommend that it be cleaned and re-painted to prevent further corrosion by a qualified contractor.

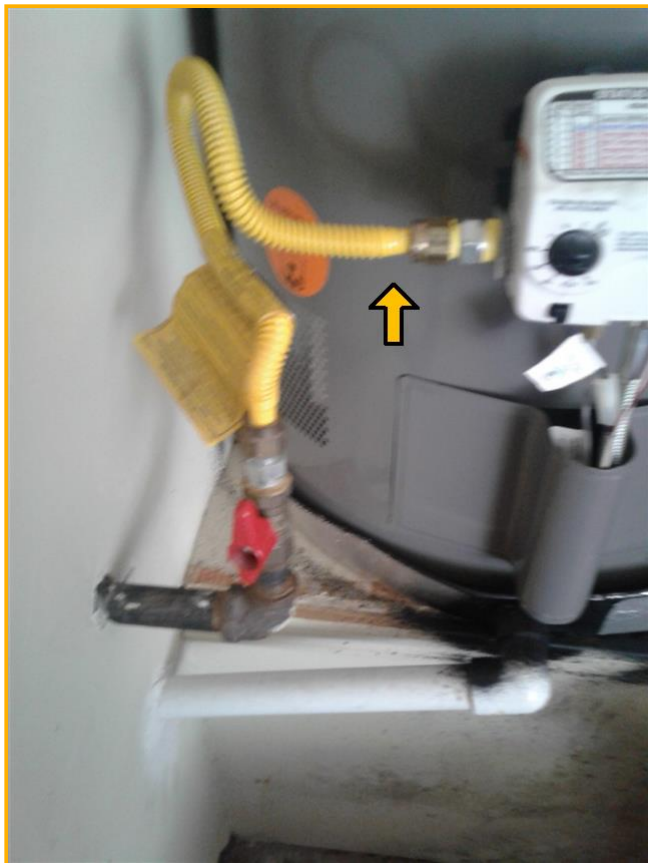
A. Item 4(Picture)

(5) Gas supply line did not have a sediment trap installed between the shutoff valve and the water heater, which could more easily allow contaminants to get in the burner reducing efficiency. Recommend that sediment traps be installed on all gas appliance connections by a qualified contractor.

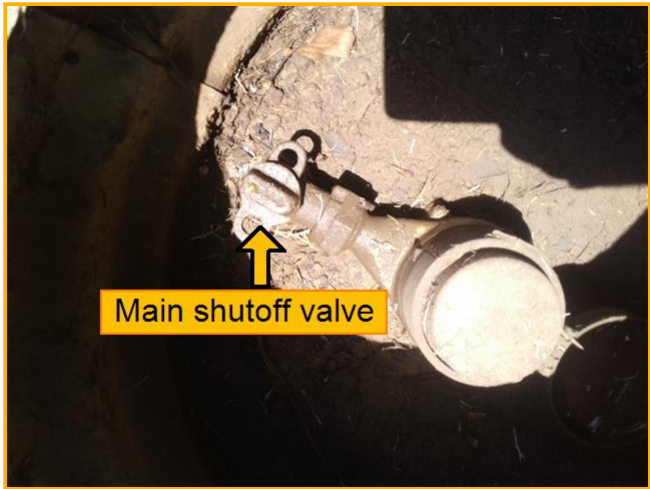
A. Item 3(Picture)

(4) The main water shutoff for the house was adjacent to the water meter, which requires a tool to shutoff the water supply in the event of an emergency or for maintenance. Recommend that a water shutoff tool be kept on hand for ready access to rapidly shut off the water supply when needed.

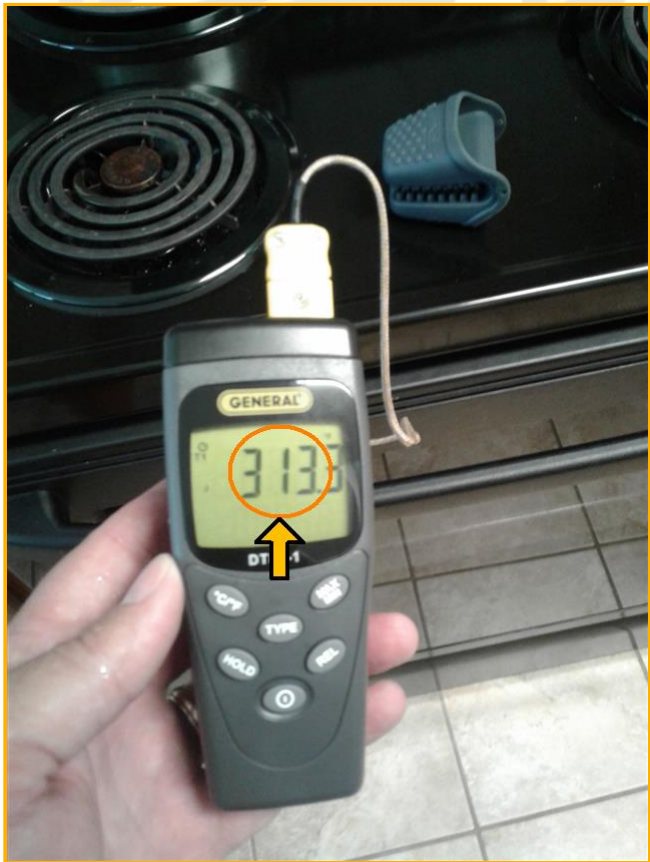
D. Item 1(Picture)

The oven(s) was tested for the accuracy of the thermostat with it set at 350 degrees F. The oven showed a temperature variance of 37 degrees below the set temperature. Recommend that the thermostat be replaced if desired by a qualified appliance technician.
