Inspection Report

PROPERTY INSPECTION REPORT

Concerning: xxx Sample Street, Forney, TX 73135

By: Ted Wulff TREC Professional Inspector License #22688 / Buy Smart Home Inspections 10/
27/2017

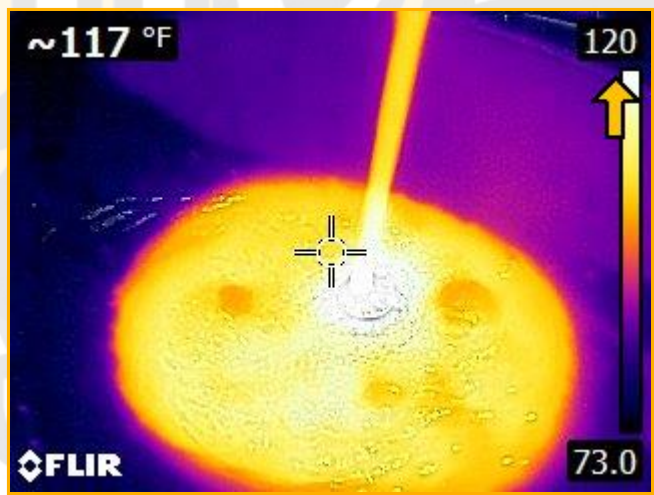
C. Item 1(Picture)

The water temperature was within the maximum of 120 degrees for the prevention of scalding to occur to occupants using the hot water. No further action needed.

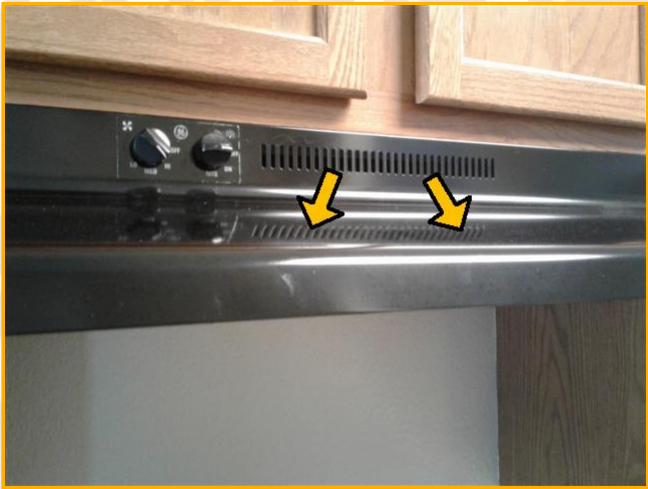
C. Item 1(Picture)

The vent hood was inspected and is working as designed. It should be noted that the vent hood is a recirculating type rather than one that vents to the exterior of the home. This utilized a charcoal filter to help clean the exhaust air before it comes back into the kitchen and is a common type of vent hood.

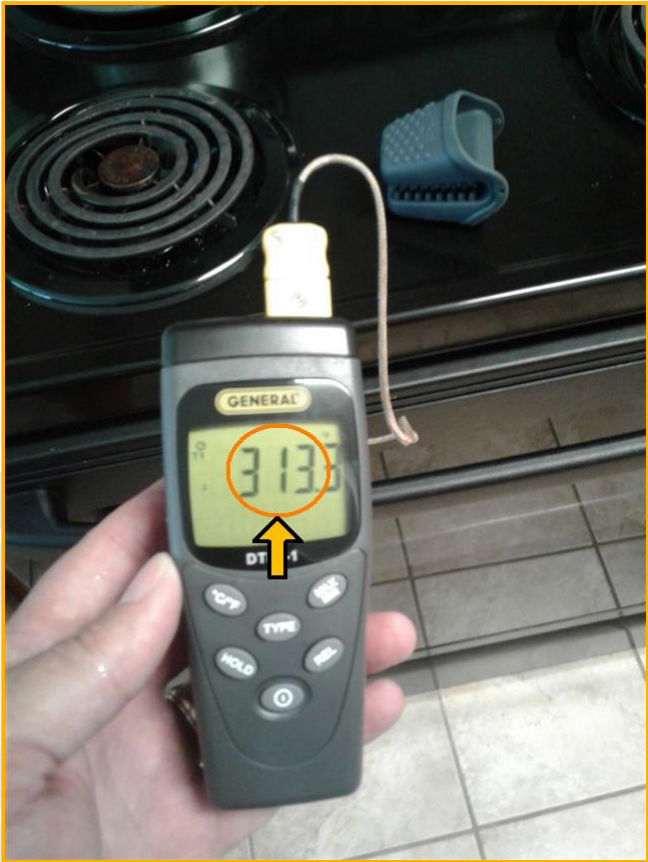
D. Item 1(Picture)

The oven(s) was tested for the accuracy of the thermostat with it set at 350 degrees F. The oven showed a temperature variance of 37 degrees below the set temperature. Recommend that the thermostat be replaced if desired by a qualified appliance technician.

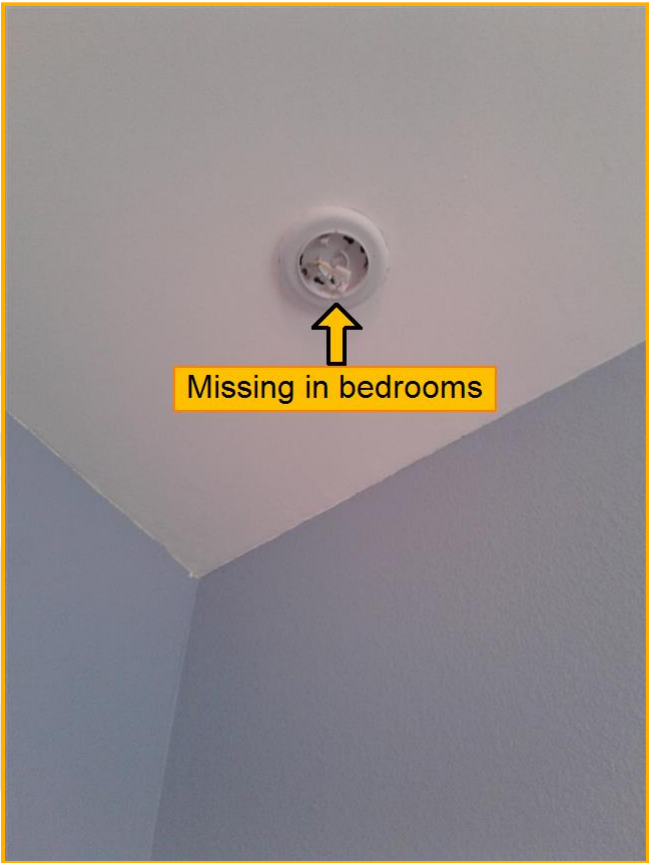
B. Item 10(Picture) Bedroom

(7) Smoke alarms are required to be placed in all bedrooms and outside them in the adjacent room/hallway. Additionally a carbon monoxide (CO) alarm is required to be outside of each bedroom area. The smoke alarms were missing from the bedrooms and no CO alarm was installed. All smoke alarms should be AC powered and interconnected. These are safety issues for protection against fires or carbon monoxide poisoning.

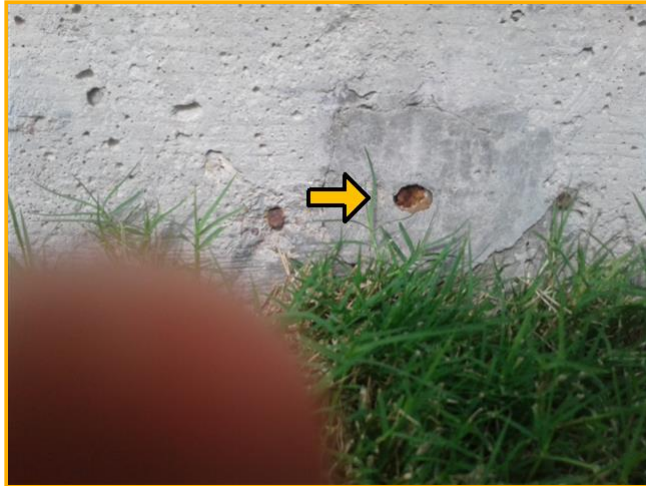
A. Item 4(Picture)

(4) Exposed/rusted post tension cable ends existed at the rear perimeter beam indicating the need for remedial action. Exposure to the elements can cause rusting and reduced strength. Per the Post-Tensioning Institute (PTI), the tendon tails should be cut back from the face of the foundation approximately 1" and the tendon pocket then filled with a non-shrink grout. An alternative method allows the grout covering the tendon to be reduced to 1/8" provided an approved tendon protection cap is installed. PTI

requirements should be complied with. Please note that some areas of the perimeter beam(s) was/were hidden from view by soil, vegetation, or flatwork, therefore, other exposed/rusted cable tendons may exist.

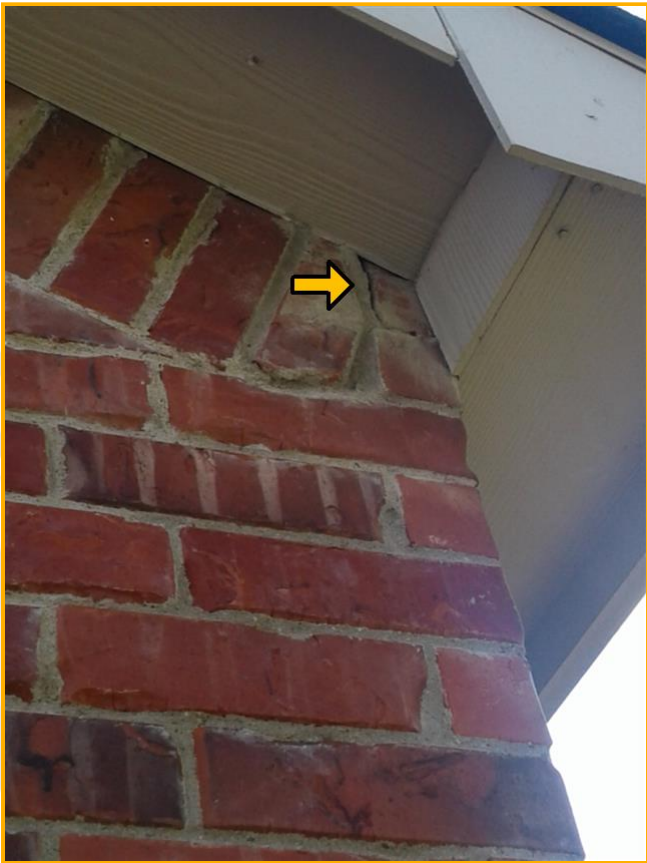
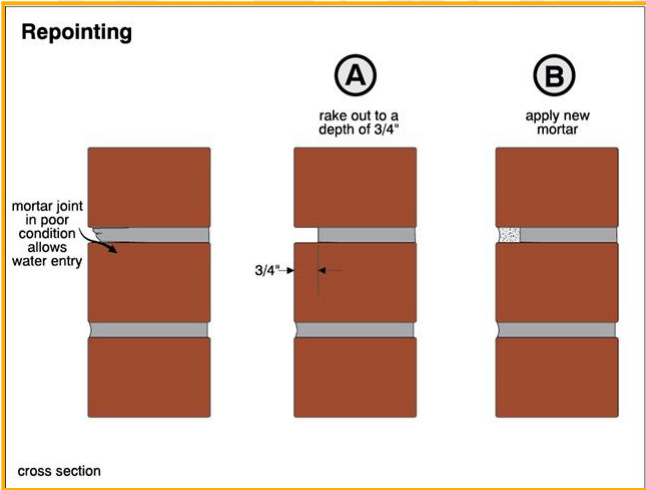
(1) The mortar joints in these areas are subject to further deterioration and moisture intrusion. Recommend that they be re-pointed by a qualified mason to prevent this future deterioration.

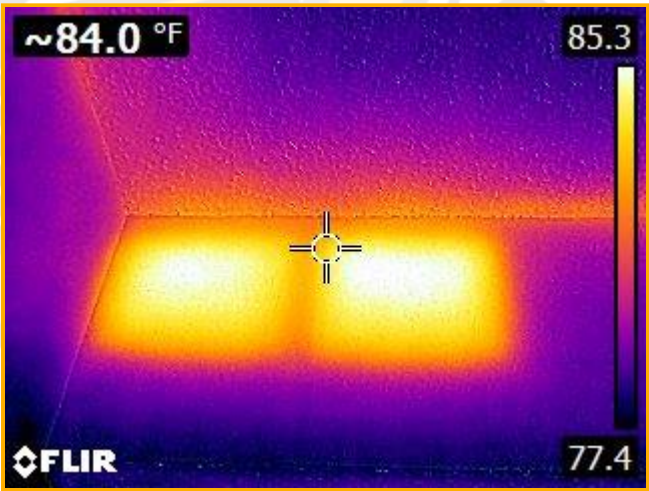
E. Item 6(Picture) Hallway entrance

(3) The anomalies depicted in the thermal image below (red/yellow area) indicates warm/hot temperatures which may be due to insufficient insulation, missing insulation, or insulation voids. An appropriate contractor should be retained for further evaluation and needed action. NOTE: This evaluation should not be considered as an energy audit. An appropriate contractor should be retained if an energy audit is desired.

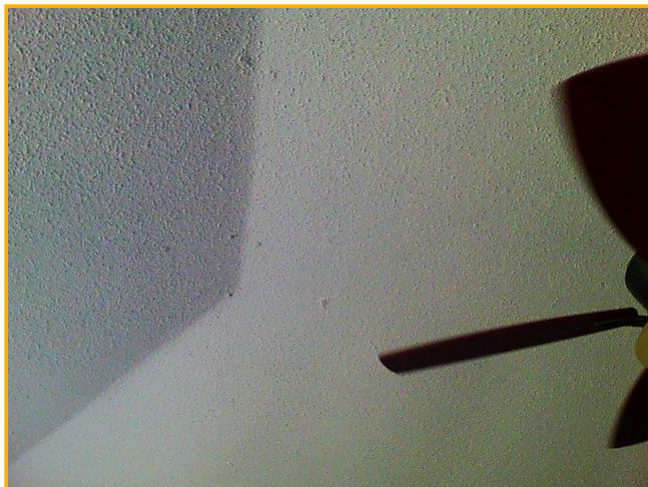
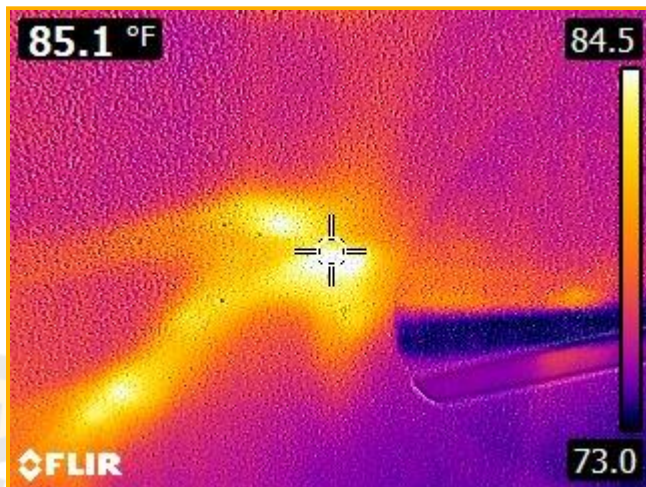
(2) The anomaly depicted in the thermal image below (red/yellow area) indicates warm/hot temperatures which may be due to insufficient insulation, missing insulation, or insulation voids. An appropriate contractor should be retained for further evaluation and needed action. NOTE: This evaluation should not be considered as an energy audit. An appropriate contractor should be retained if an energy audit is desired.

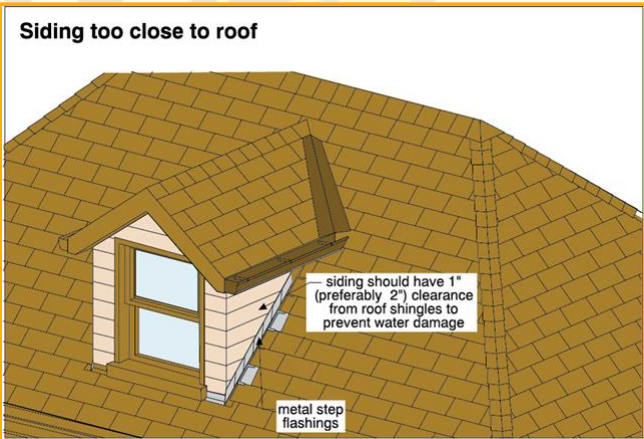
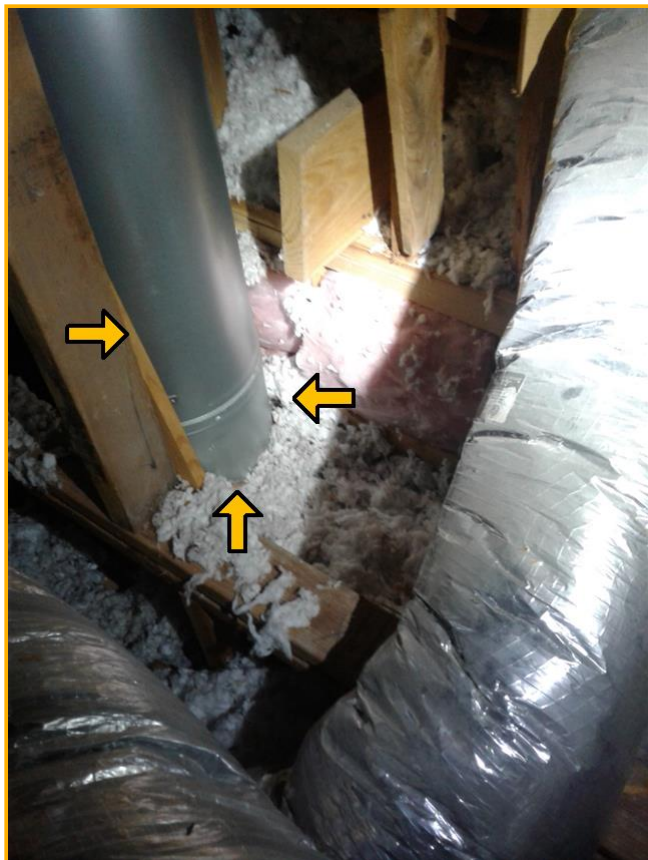
(4) The chimney did not have adequate clearance form combustible components and can become a fire hazard through the process of pyrolysis. Pyrolysis is a process where wood products change chemically to ignite at a lower temperature when continually exposed to heated surfaces.

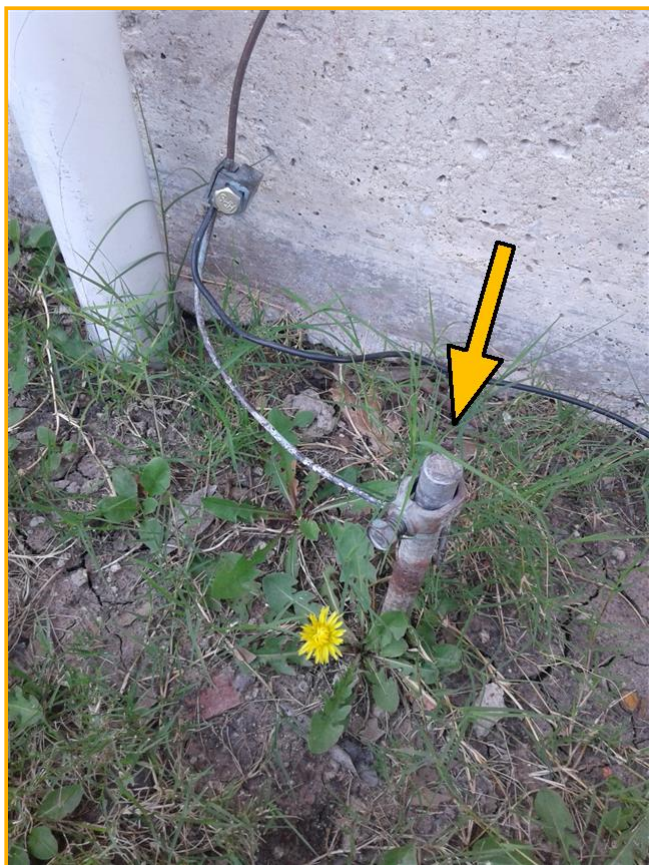
B. Item 1(Picture)

(2) The ground rod was not driven all the way into the ground, which can compromise it's ability to ground the home wiring circuit. The ability of the grounding system to handle any likely grounding situation can only be validated by a licensed electrician however.

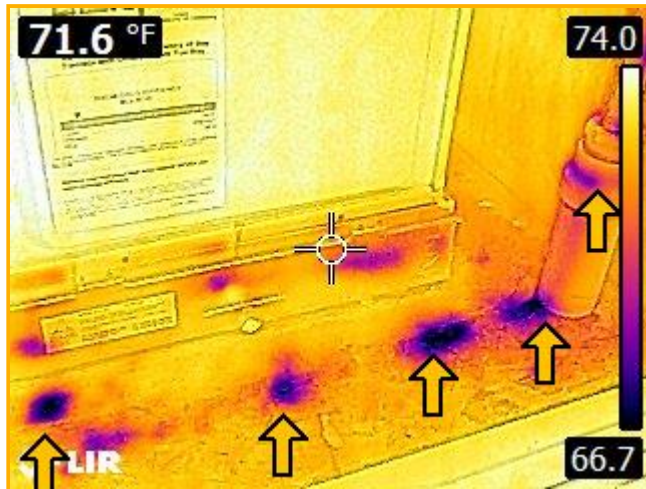
B. Item 2(Picture) Floor Below Condensate Line

(3) The condensate drain line connected to the air conditioning evaporator coil pan is condensing moisture on it's exterior and dripping in the area below which provides potential for moisture damage. Recommend that the condensate line be insulated to prevent condensation on the outside of the condensate drain pipe by a contractor.

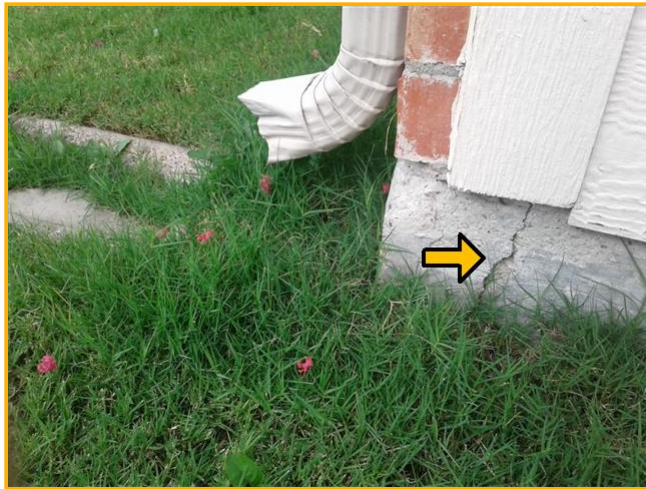
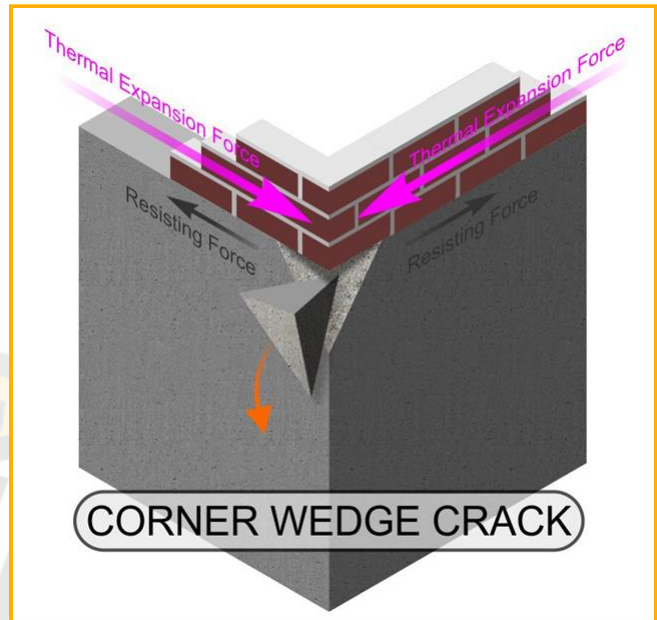
(2) The slab had wedge fractures in some corners. This is caused by differential movement between the masonry walls and the concrete foundation. The corner fractures did not appear to adversely affect the structure. The cracks should be monitored to be sure that further concrete degradation does not cause the foundation brick ledge to be undermined leading to inadequate support of the bricks and required repairs.

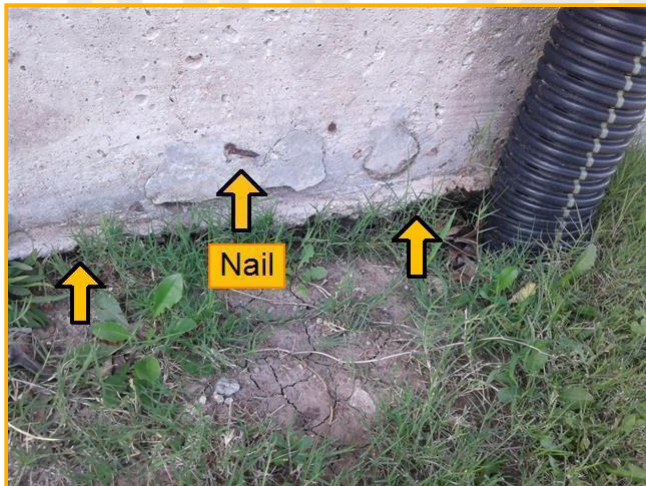
A. Item 3(Picture)

(3) The foundation was undermined by erosion cause by water. The owner indicated that the underground drainage pipes attached to the downspouts were installed after this problem was detected as a solution. This appears to be an adequate solution, so no further repairs are recommended other than removal of the rusty nail, which may cause injury.
